UTILITY ACCIDENT INVESTIGATION REPORT

Utility:	LG&E Energy Corp. ("LG&E")	
Reported By:	Marty J. Reinert, LG&E	
Accident Occurred:	DATE – September 18, 2002	TIME - Approximately 3:20 PM
Utility Notified:	DATE - September 18, 2002	TIME - Approximately 3:20 PM
PSC Notified:	DATE - September 18, 2002	TIME - 3:45 PM
Investigated:	DATE - September 18, 2002 FOLLOW-UP – October 1, 2002	
Written Report Rcvd:	DATE - September 23, 2002	
Location of Accident:	FOX RUN SUBDIVISION – OFF OLD HENRY ROAD, EASTERN JEFFERSON COUNTY (New construction – no known address)	
Description of Accident:	<p>At the start of the job(s) Fishel Electric ("Fishel") and Pike Electric ("Pike") Companies had been assigned to do, Pike Foreman, Dominick Simms, and Fishel Foreman, Chad Best, did not recognize that they would need a grounding elbow. LG&E supervising personnel discovered this and stated that a grounding elbow was furnished to the job site.</p> <p>During the initial investigation of the accident, LG&E personnel discovered that a grounding elbow was found on a Pike electrical truck.</p> <p>When the underground ("UG") system was energized, the morning of the accident, a fault occurred and one of the two (2)

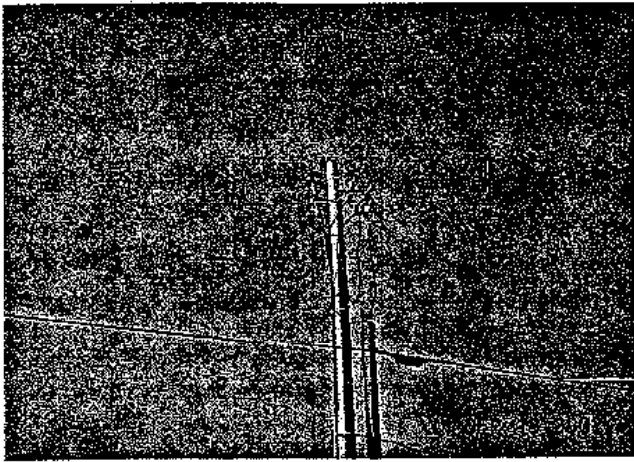
Underground "Drop Pole" Feed for Subdivision

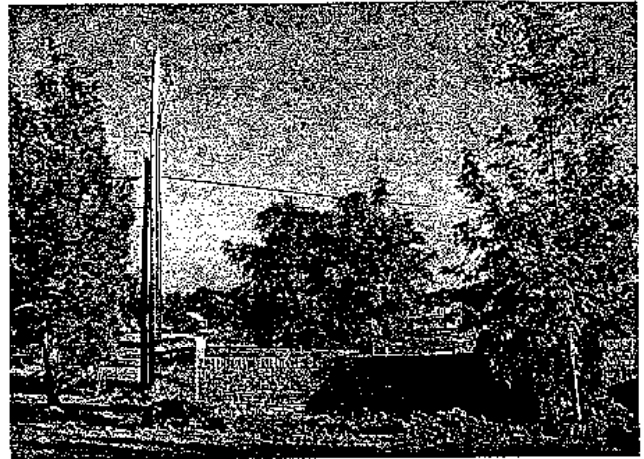
View from drop pole to accident sight (behind house)

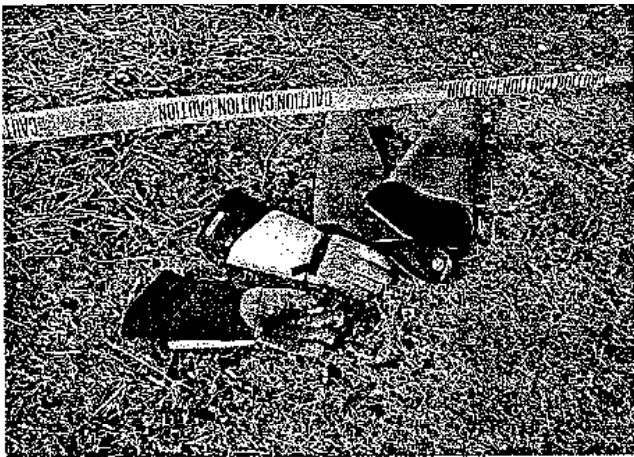
Accident area with PPE on-sight

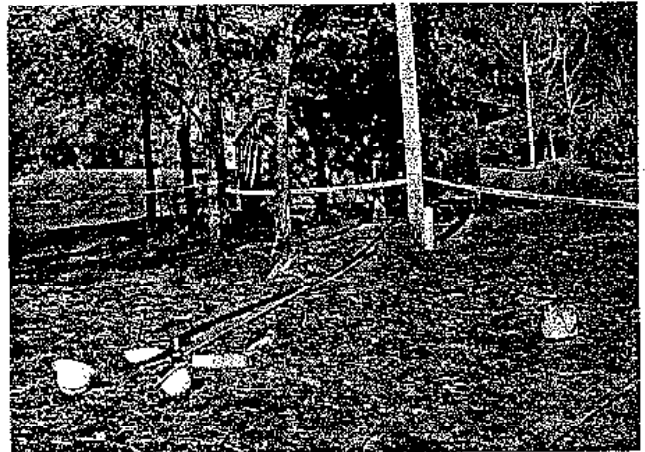
Accident area with PPE on-sight

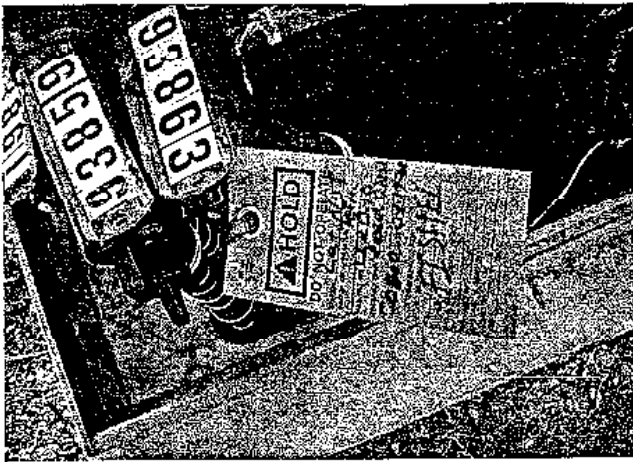
<p>Fishel Foreman Best had attached a red Hold Card to the elbow on the double feed-through bushing on the URD transformer. The red Hold Card was visible to Pike Foreman Simms and other personnel at the site. Best improperly used a red Hold Card as a message card, instead of a white Message Card. LG&E's normal practice is to use a white message card for information or instruction (during subsequent interviews). Best said, "I did not know to use a white card for messages, but I do now."</p>					
Victims:						
Name:	Walt Walker	Fatal:	YES	Age:	46	
Addr./Empl.:	23268 #8, Huntington, WV Pike Electric Company, Mt. Airy, NC					
Injuries:	Electrocution

Pad Mount Transformer showing installed card and cable terminations

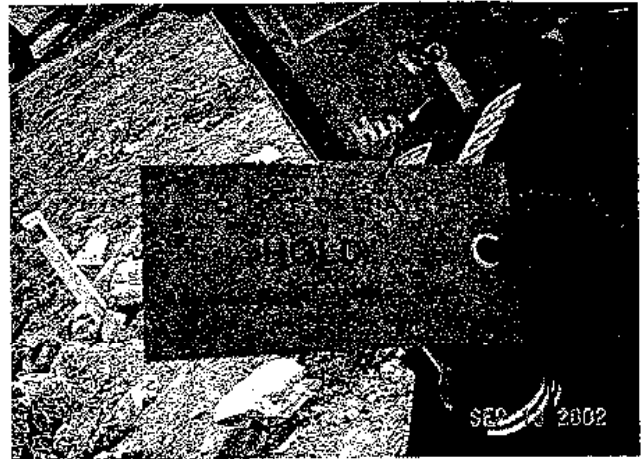
Card installed

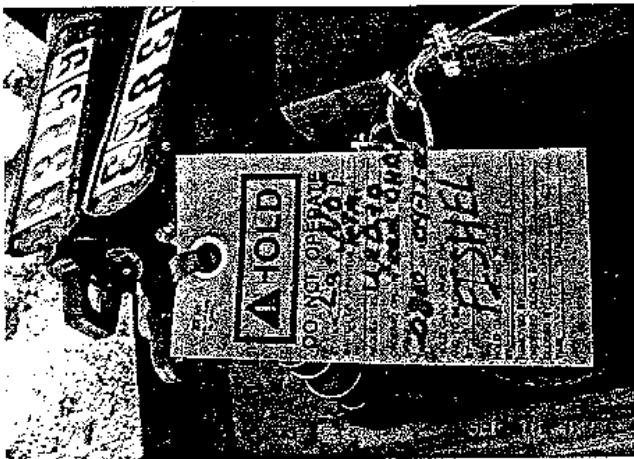
Wording on installed "Card"

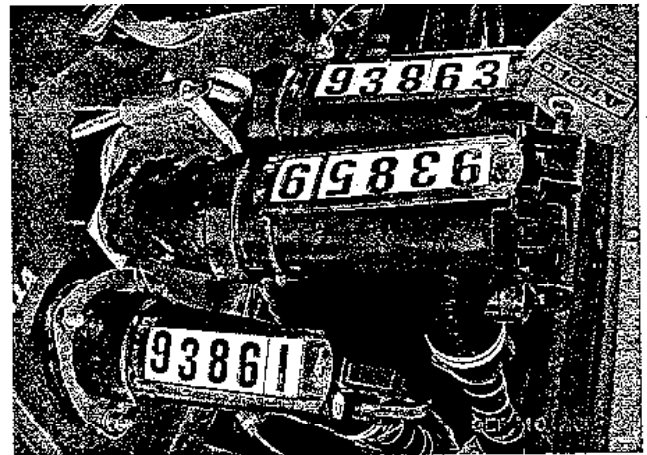
Subsequent inspection of the transformer and the lateral line found that the lateral line that the Pike employees were working on was plugged into a double feed-through bushing. The other URD cable coming from the first transformer and feeding the entire subdivision was plugged into the other side of the *same* double feed-through bushing. When Fishel energized the first transformer, they energized the subdivision's URD cable and the lateral line at the same time. Photographs and measurements were taken of the scene.

Transformer/Cable Terminations

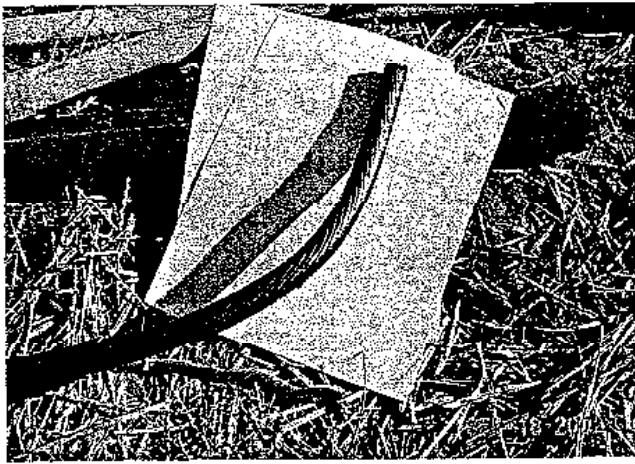
Cable End ~ Accident Contact Burn/Arc Marks

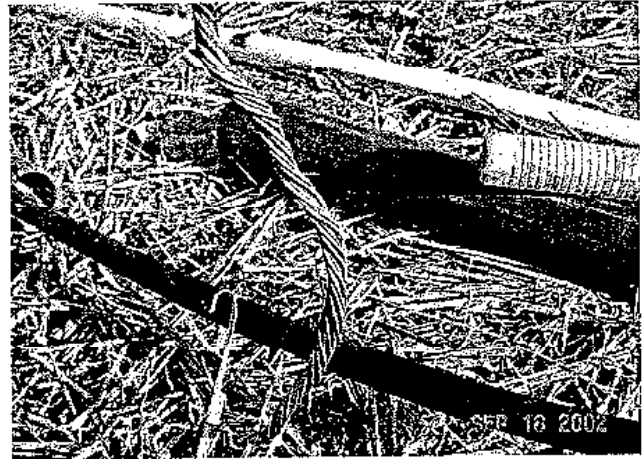
Cable Neutral ~ Burn/Arc Marks

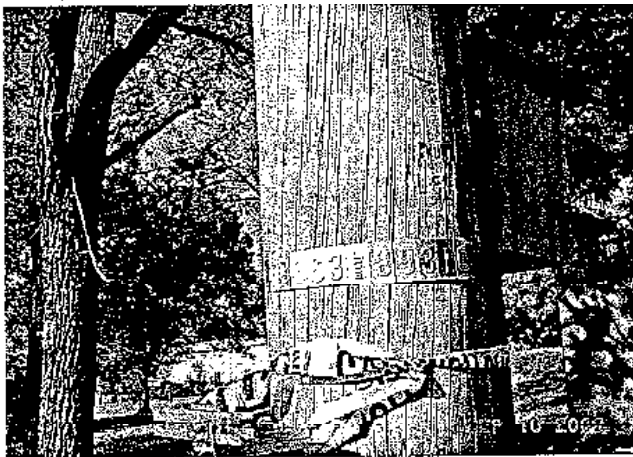
Lateral Pole At Accident Site

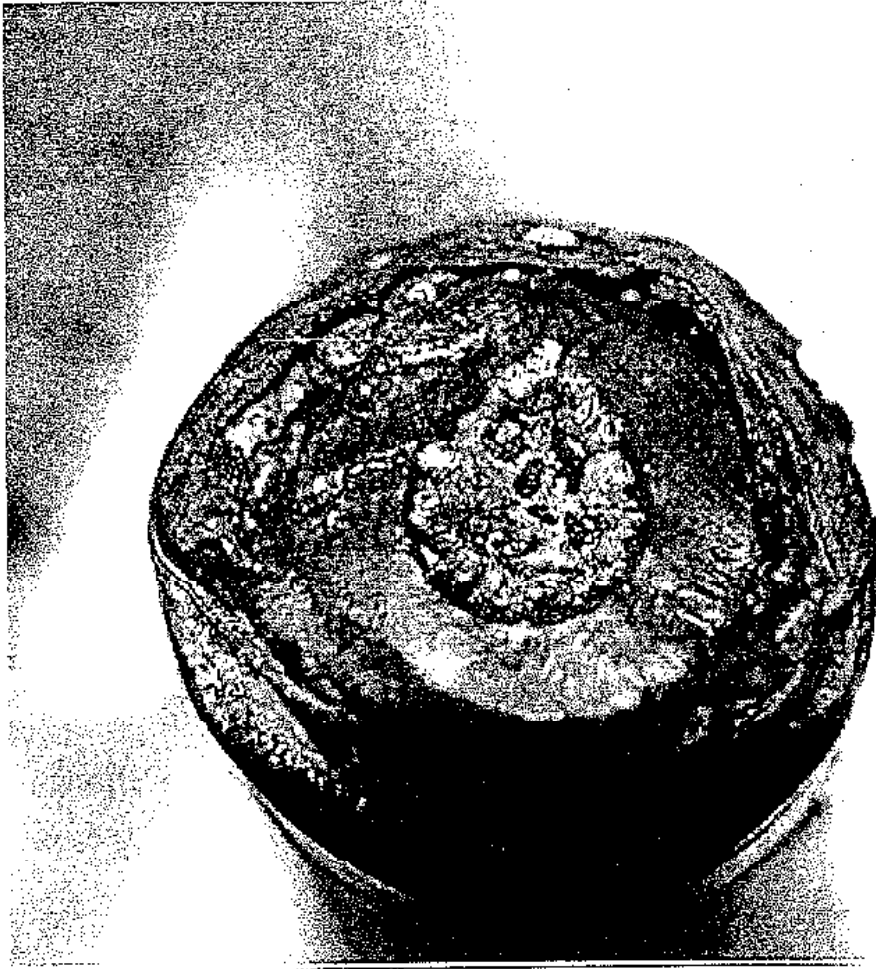
LG&E ACCIDENT ~ 09/18/2002

This section of cable is the portion apparently removed from the underground lateral by Mr. Walker prior to the accident that resulted in his fatality.

The cable shows results of arcing that was apparently due to the initial fault.
